INVESTIGATION OF THE EFFECTS OF FLUORINE ON CRYOPANEL MATERIALS FOR SPACE CHAMBER PROPULSION TESTS

P. G. Waldrep and D. M. Trayer

ARO, Inc.

September 1968

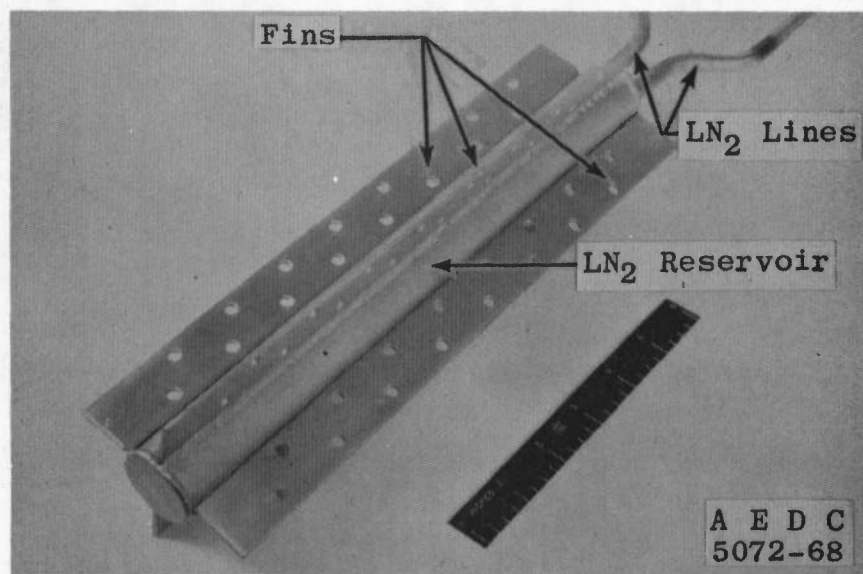
Fig. 3 Specimen Holder

The specimen holder (Fig. 3) was a stainless steel cylinder 10 in. long and 1.25 in. in diameter to which four longitudinal metal fins were welded. The fins, two of copper and two of stainless steel, served as mounts for the test specimens. One end of each specimen was sandwiched between a holder fin and a metal strip cut and drilled to match the fin. Specimens were bolted between the fins and strips. Copper screws and bolts were used for attachments to copper fins and stainless steel screws and bolts for the stainless steel fins. Specimens are shown mounted to the holder in Fig. 4.

Liquid nitrogen circulated through the cylindrical portion of the specimen holder during cooling. Fin temperatures were measured with stainless steel sheathed thermocouples attached near the ends of the fins.

When inserted in the chamber, the holder was surrounded by a cylindrical stainless steel LN₂-cooled shroud. The shroud was open at the ends for access of corrosive vapor.

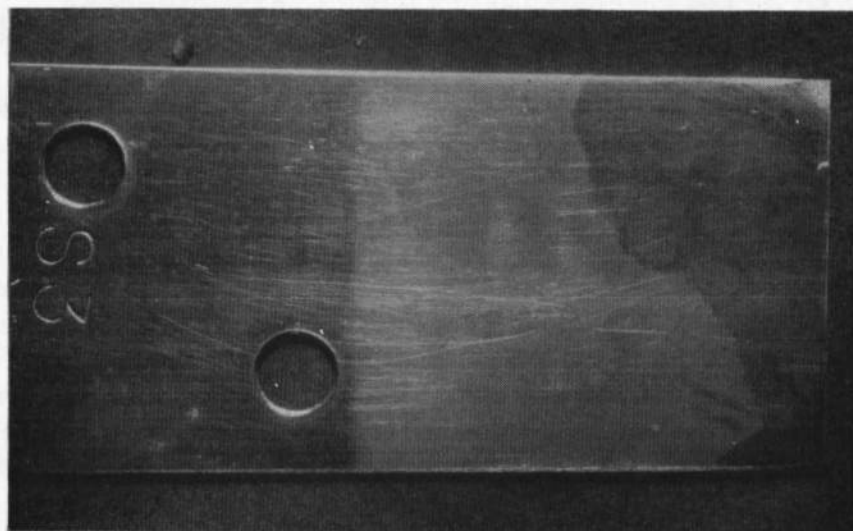
Fig. 6 Unwelded Stainless Steel 304L, Exposed to F_2 , 2X

Several of these specimens showed a light, hazy surface film. This is visible in Figs. 6 and 7. The film could not be identified by X-ray diffraction, but the presence of fluoride is verified by the total fluoride and electron microprobe analyses (Tables I and II). More fluoride was found on the welded specimens than on the unwelded (82 versus $65 \mu g F$). This is believed to be caused by a reaction between the oxides formed near the weld and F_2 rather than to an enhancement of the base metal reaction as a result of welding, since oxide was visibly present near the welds before exposure and could not be removed by vigorous wire brushing. The microprobe analysis demonstrated a higher concentration of fluoride in the weld region than in the metal away from the weld.

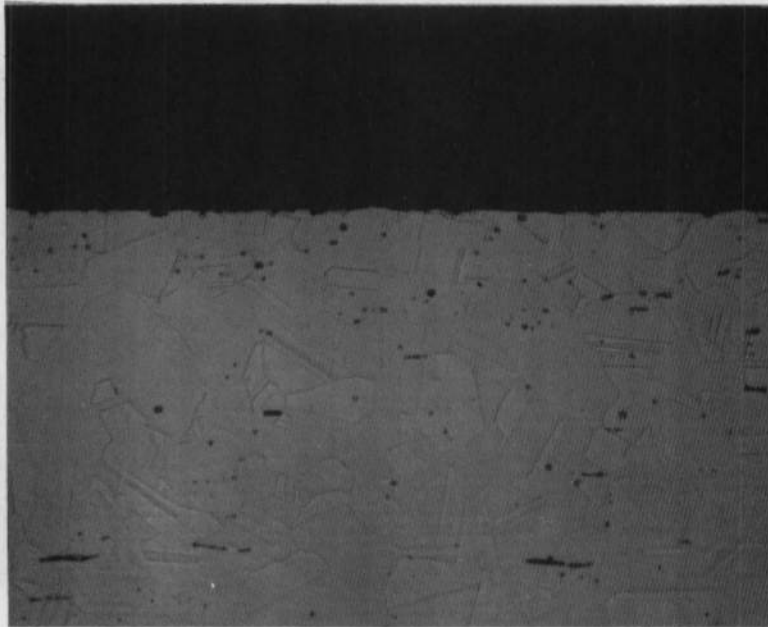
Fig. 8 Control, Unwelded Stainless Steel 304L, Unexposed, 500X

Metallographic examination of specimen cross sections showed no indications of pitting, intergranular corrosion, or stress-corrosion cracking. Photomicrographs at 500X magnification are shown in Figs. 8 through 12. Figure 8 shows a control specimen and may be compared with Fig. 9, which shows a similar specimen from the test. There were no indications of significant corrosion from pitting or intergranular attack either at the welds or away from the welds. Figure 10 shows the cross section of a weld in an unexposed control specimen. Figures 11 and 12 show similar photomicrographs taken of a test specimen at the weld and away from the weld. No effect was noted as a result of imposing external stress on the specimens, as is evidenced by Figs. 10, 11, and 12.

Metallographic examination of each component of the composite specimens revealed no difference in the corrosive action compared to single specimens of the same material. No pitting, stress-corrosion cracking, or intergranular corrosion was found in either the stainless steel, the copper, or the nickel weldment. The copper portions were tarnished in the same manner as the all-copper specimens, Fig. 20. The stainless steel portion was covered with a light film. Figures 21 and 22 show photomicrographs of unexposed control specimens at the welds. These may be compared with Figs. 23 and 24 showing similar regions of test specimens which were exposed to F_2 under applied stress. Figures 25 and 26 show that the base metals were unaffected by exposure and stress. These may be compared with control specimens shown in Figs. 15 (copper) and 8 (stainless steel).

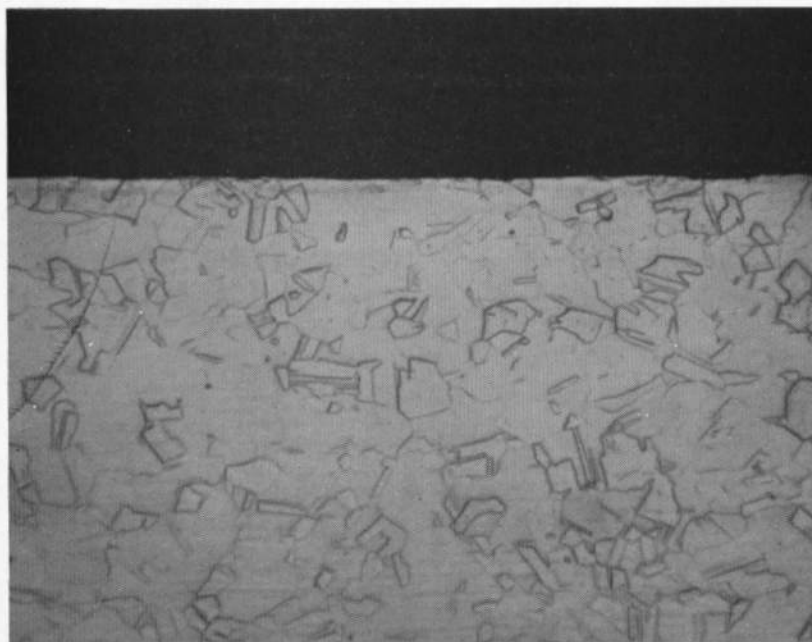
Fig. 15 Control Copper Specimen, Away from
Braze Joint, Unexposed, 500X

The copper shim stock showed no indications of structural corrosion. Figures 15 and 16 show an unexposed control and an unstressed test specimen at 500X magnification. There are no grain boundary corrosion effects and no pitting. The slight surface roughening is typical of specimens cleaned in acetic acid solution before testing.

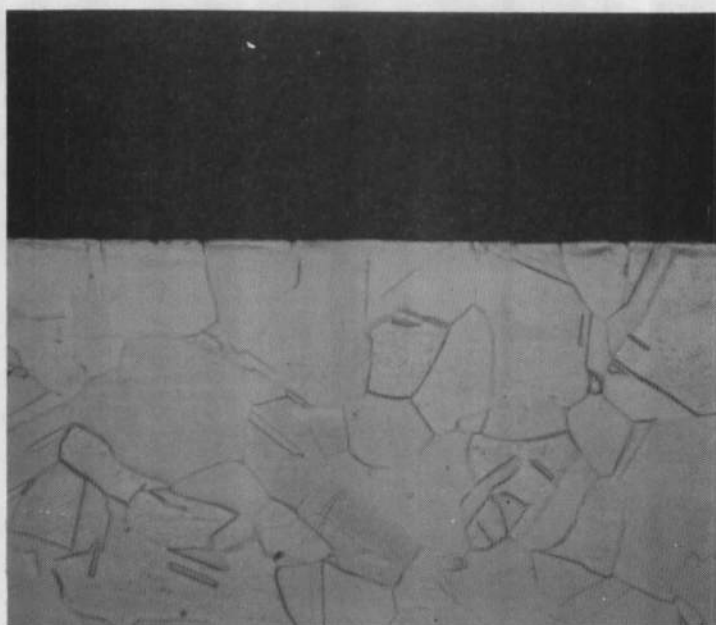
Fig. 17 Bronze Welded Copper, Near Weld, Stressed,
Exposed to F₂, 500X

Figure 17 is a photomicrograph of a phosphor bronze welded copper specimen taken near the weld. Here again, there is no indication of corrosive action. This specimen is the same one that appears in Figs. 18 and 19 and was under bending stress during the F₂ exposure. The presence of stress apparently exerted no influence on corrosion activity in any of the copper specimens tested. The grain enlargement appearing in the specimen in Fig. 17 resulted from the welding heat and is characteristic of metals in the vicinity of weldments.

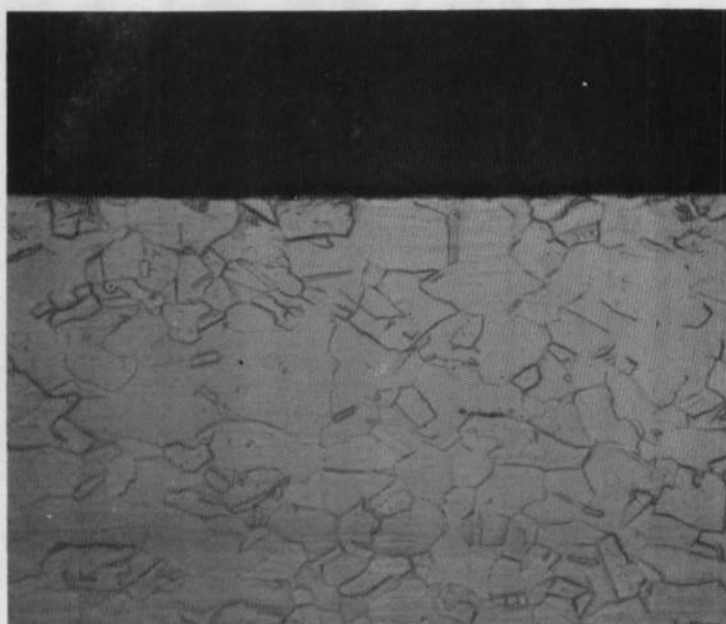
Fig. 25 Copper Shim Portion of Composite Specimen, Away
from Weld, Exposed to F_2 , Stressed, 500X

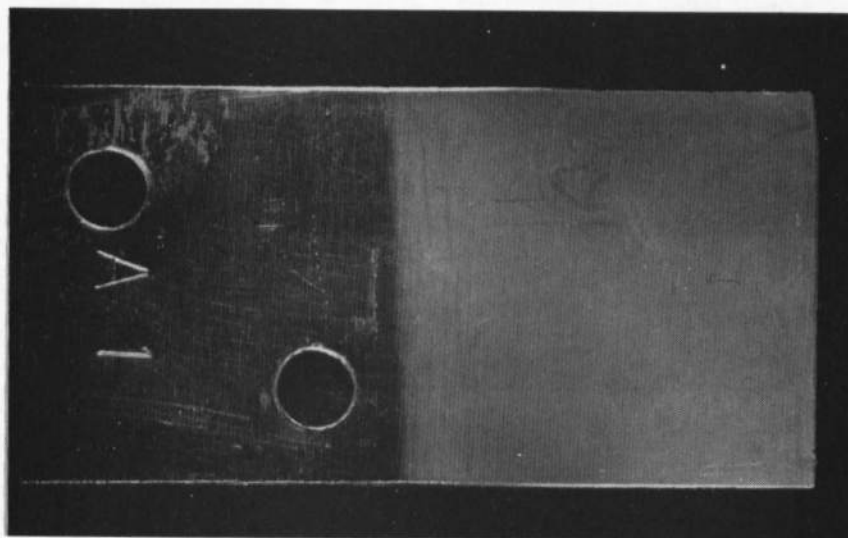
Fig. 27 Aluminum Specimen, Exposed to F_2 , 2X

The aluminum specimens all had a light, hazy surface film as a result of exposure, as shown in Fig. 27. Fluoride analyses of this film yielded the highest levels of fluoride found on any specimen. The presence of this film led to a suspicion that HF had been formed in the test chamber at some time during the test, probably as a result of in-leakage of atmospheric moisture. A verification of the presence of HF was made by exposing several clean aluminum specimens to 0.5 atm of dry F_2 at about 70°C for 48 hr. The specimens were bright and visibly unaffected after this exposure. However, the white film was formed very rapidly on the surface of specimens dipped in hydrofluoric acid at room temperature.

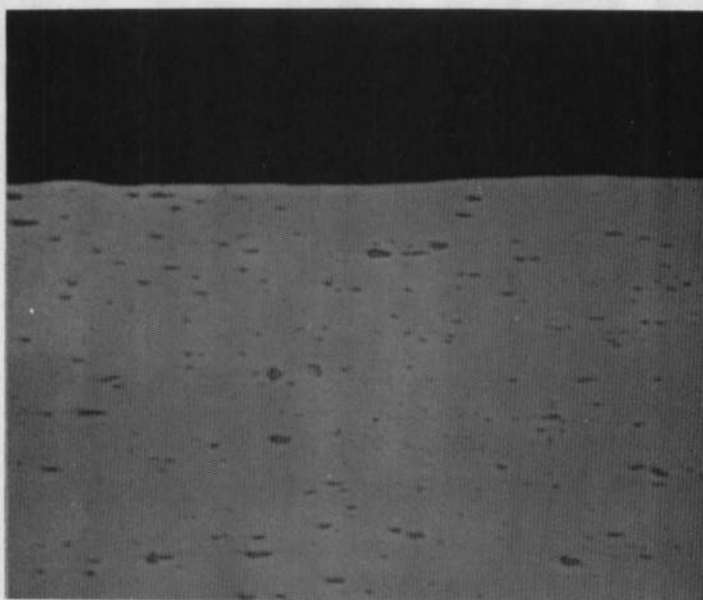
Fig. 28 Control Specimen, Unexposed
Aluminum, 500X

Despite the attack apparent from the surface film, metallographic examination revealed no evidence of structural corrosion other than a slight roughening of the surface. Control and test specimen photomicrographs are shown in Figs. 28 and 29.

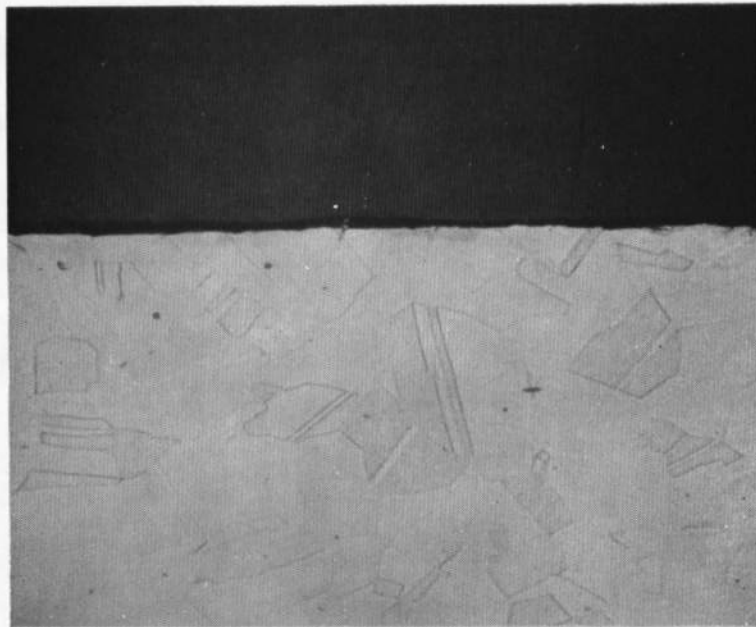
Fig. 30 Control, Stainless Steel Cryopanel,
Unexposed, 500X

There was no evidence of significant corrosive attack on the stainless steel cryopanel material. A light haze, similar to that found on the stainless steel shim, was present. Photomicrographs of a control specimen and the test specimen are shown in Figs. 30 and 31. Metallographic examination of sections at the welds indicated no corrosive action on weldments. No fluoride determinations were made on the surface film.
